Case Vehicle (A): 1998 Chevrolet

Type: Malibu LS, 4-door sedan Driver: 51-year-old female

Veh. (B): 1997 Chevrolet

Type: Sierra C1500 4 x 2, extended cab pickup

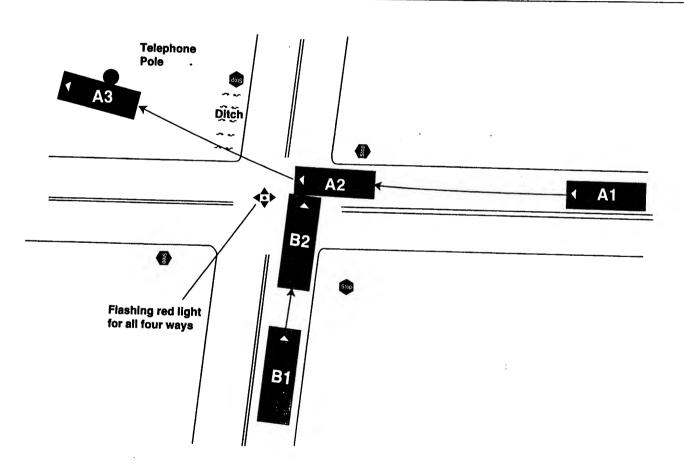
ACCIDENT DESCRIPTION: Case vehicle (A) was traveling west and Case Vehicle (A): 1998 Chevrolot Malibo

vehicle (B) was stopped at a stop sign facing nonth. OTHER VEHICLE (B): 1997 Chevrolot cisoo PU

As vehicle (B) began to enten the intersection, case THIRD VEHICLE (C):

vehicle (A) proceeded into the intersection and the left-front was struck by the frontof vehicle (B). Case vehicle (A) veened to the pight, went through a ditch,

on a lawn and sideswiped a utility pole.

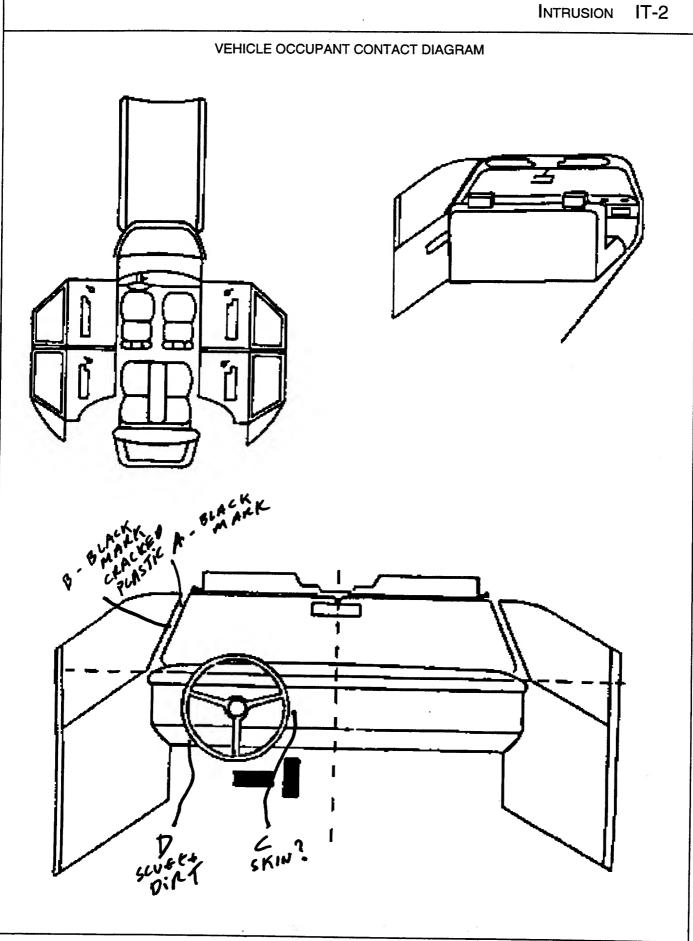
Intrusio	N IT-1
					(All Measurements Are in Centimeters)	
Location Intrusio	of on	Intruded	l Component	Compai Valu	ison Intruded e — Value = Intrusion	Dominant Crush Direction
					- =	
					_ =	
					= =	
					_ =	
					_ =	
					- =	
					_ =	
					_ =	
					_ =	
					_ =	
					=	
					- =	
					_ =	
		- 1-			_ =	
					= :	
			0	CCUPANT C	ONTACT WORKSHEET	
Contact	I Co	nterior mponent entacted	Occupant No. if Known	Body Region if Known	Supporting Physical Evidence	Confidence Level of Contact Point
Α	A-A	pillAa	On	Handfren	Black mark	3
В		11	//	11	Black mark cracked plastic Skiw on tood	3
С	I.	P	11	//	Skiw on tood	2
D	Ku	e bolsten	11	u. Knee	Scuft	/
E						
F						
G						
Н						
ı						
J
